A technical investigation of an oil painting on copper support, including a study on consolidants for treatment

Dissertação para obtenção do Grau de Mestre em
Conservação e Restauro, especialização em pintura

2. Condition report

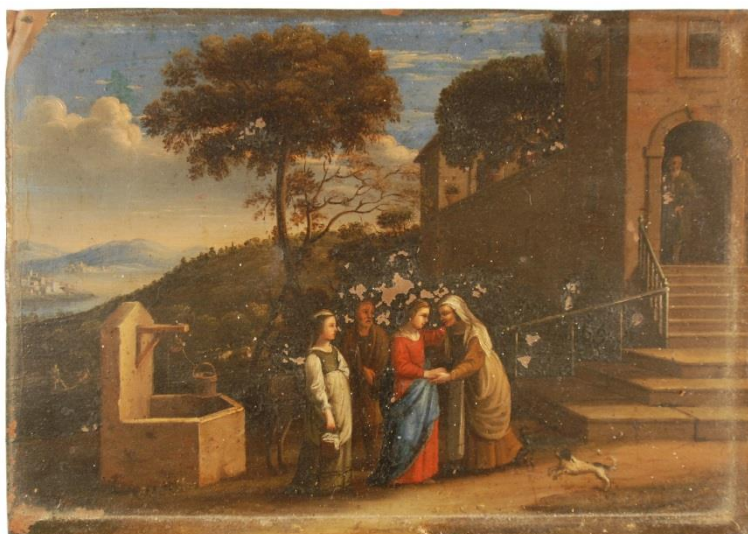
Figure 1 – Overall before treatment photograph of *Visitation* in normal light.

Visitation exhibits significant active flaking paint problem, mainly evident in darker areas of paint, which has resulted in several paint losses spread throughout the painting. For this reason, it is considered to be in a poor, unstable condition. It probably has been in this condition for some time, due to evidence of having the pictorial layers extensively restored. The same darker areas display significant differences in terms of texture by comparison with the remaining colours, being much textured and exhibiting several “lumps”, while the others are considerably smoother.

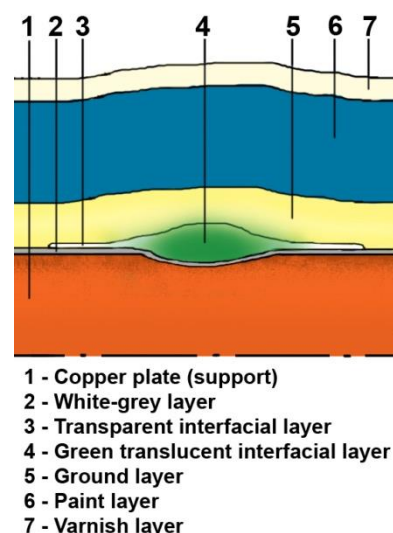
Figure 3 – Proposed stratigraphy.

1. A very thin, translucent green layer, showing no signs of individual particles, is found coating unevenly the bottom of the ground layer, immediately above the copper plate (see proposed stratigraphy in Fig. 3). It appears more concentrated in some areas and less – or nothing – in others (varying between 1.5µm–6µm, according to cross-sections evidence) (see Appendix II, Fig. II.4 and II.5). This unevenness may be due to the fact that, as mentioned further in Section 3, the copper plate was scored and sanded before paint application, therefore having grooves in which this layer may have been more prone to grow. Visual evidence suggests that this substance does not usually behave like an independent layer from the ground, for it seems to be tinting the preparatory layer in the places where it starts to appear. A variation in colour saturation is visible (in cross sections and on the back of paint losses where it sits directly on top of the ground), ranging from a paler, more translucent green, to a richer, denser one – an aspect that seems to be directly related to the layer thickness (thicker meaning denser and greener, and vice versa). An increase in thickness, associated with bigger areas, also seems to be related to the appearance of micro fissures, indicative of a fragility and lack of internal cohesion in the material. This layer does not fluoresce in UV (Pavlopoulou [15] reported a similar layer between the ground and a copper substrate on an oil painting, also non-fluorescent in UV).

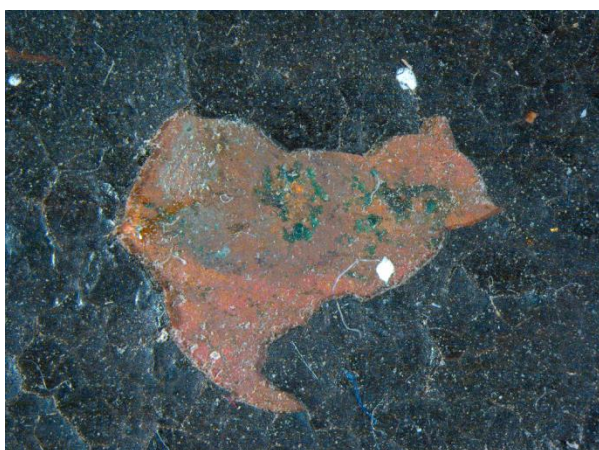
Both surfaces of the copper plate – the front surface being visible through paint loss areas – are oxidized, resulting in an overall tarnished and stained appearance; and exhibit localized vivid green copper corrosion products, either in the form of small-sized, rounded crusts (ranging between approx. 0.5-5mm) or as thinner layers (see Appendix II, Fig. II.1). Based on appearance and the reactions copper is known to have with moisture and the surrounding atmosphere, the oxidation layers form, under dry, unpolluted conditions, what is usually a protective patina, and are expected to be a mixture of cuprite (Cu_2O) and tenorite (CuO). In the presence of carbon, sulphur and chlorine ions from the atmosphere, corrosion products may be either copper carbonates (such as malachite - $\text{CuCO}_3 \cdot \text{Cu}(\text{OH})_2$); copper sulphates (as antlerite - $\text{CuSO}_4 \cdot 2\text{Cu}(\text{OH})_2$ - and brochantite - $\text{CuSO}_4 \cdot 3\text{Cu}(\text{OH})_2$); and/or copper chlorides (atacamite and paratacamite - $\text{Cu}_2\text{Cl}(\text{OH})_3$) [9; 13; 11].

Figure II.1- Cu corrosion on paint loss (x16).

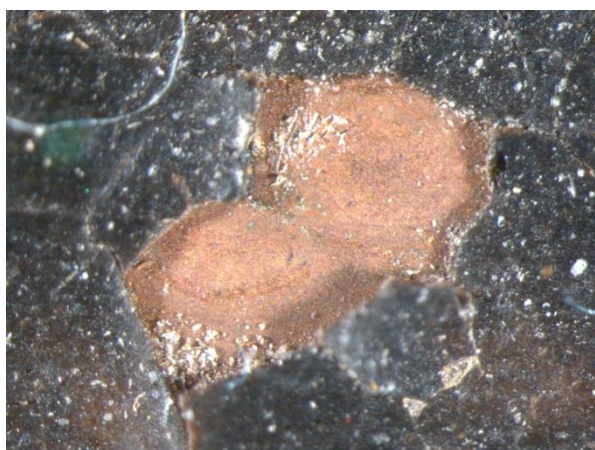
Alongside this layer, a white powdered loose substance was also noticed in every paint loss area, being deposited on the copper support as well (see Appendix II, II.2-II.3). It appears to be mainly concentrated near the paint losses' edges, and is more evident in smaller paint losses than in larger (in the latter case it has probably been eroded due to a larger portion of the copper being exposed to the outside environment). Similarly to the white-grey layer, it is very easily removable by mechanical action. It was also seen on top of the paint composite, mixed with regular dust and other deposits, though not as abundantly. The reasons for its presence are still unclear at this point and need further investigation, although one possibility is that it is residue of the ground layer that has crumbled during delamination of the paint composite.

Figure II.2- White-grey layer with powdery substance (x50).

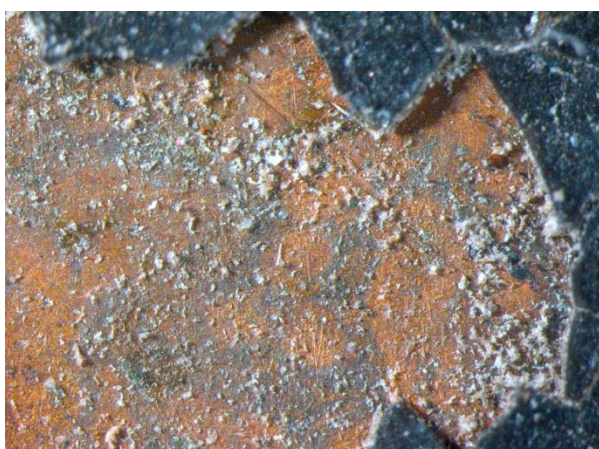
Figure II.3 – White-grey layer with powdery substance (x50).

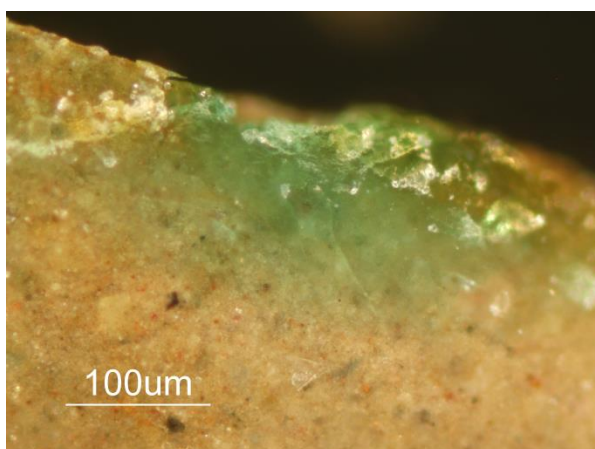
Figure II.4 – Green interfacial layer (x200).

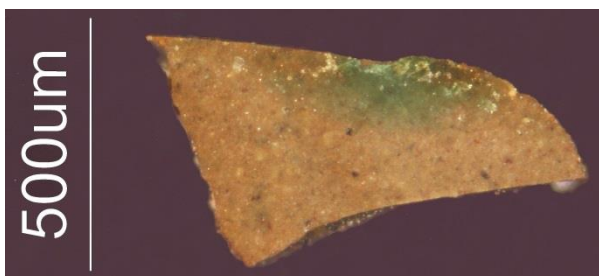
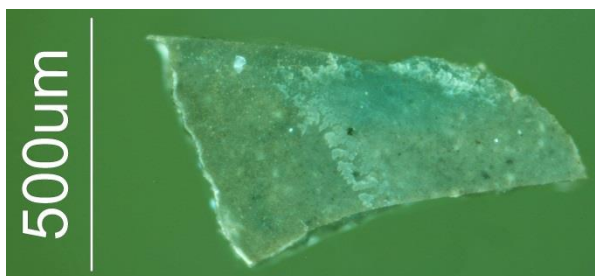
2. An extremely thin, transparent and non-particulate, vitreous looking layer has been observed, but not on every paint fragment (see Appendix II, Fig. II.5; II.6 and II.8). It is barely visible with OM with normal reflected light, on the underside of the paint composite (on the bottom of the ground) (see proposed stratigraphy in Fig. 3). Due to its thinness and lack of colour, it is not visible in cross-sections. These features also make it difficult to determine if it is thicker in some areas compared to others, and if it is yellowed or completely clear (due to the ground underneath being coloured). Observations under the OM with UV light and different filters for fluorescence (see instrument description in Appendix IV.1) showed that this substance fluoresces strongly (see Appendix II, Fig. II.5; II.6 and II.8). Because of this, it is possible to determine its location and distribution on the underside of the fragments: similarly to the green layer, it does not coat the ground evenly. It appears either in the form of continuous films and patches. In some areas, at the outside edges, it displays perfectly formed dendritic shapes (see Appendix II, Fig. II.8). Also, it occasionally exhibits a pattern with thin striations. This may be related to its method of growing on the non-porous support or, again, due to the plate possibly being scored and sanded, therefore not being a perfectly smooth surface. Micro-fissures were also detected in this layer in some areas, similar in appearance to those found in the green layer. This transparent layer sometimes appears together with the green one on the underside of the ground in paint fragments, but it was difficult to determine if it is on top of the green, or if it is a continuation of it on the sides, and if the two are merged with each other or separate. One possibility is that they are the same substance, and the presence or absence of colour is due to the layer thickness or a concentration of copper ions (the green areas having a higher concentration of copper).

Figure II.5 – Underside of paint fragment in normal light (left) and Filter set 5 (BP 395-440, FT 460, LP 470) for fluorescence (right) (x50).

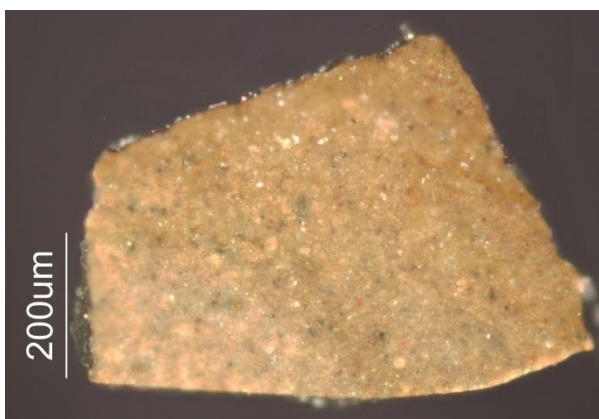
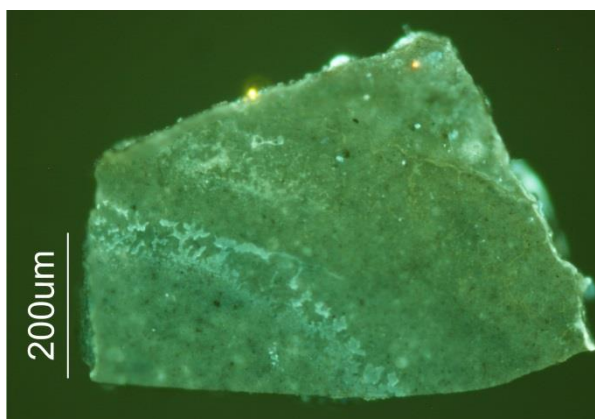
Figure II.6 – Underside of paint fragment in normal light (left) and Filter set 5 (BP 395-440, FT 460, LP 470) for fluorescence (right) (x100).

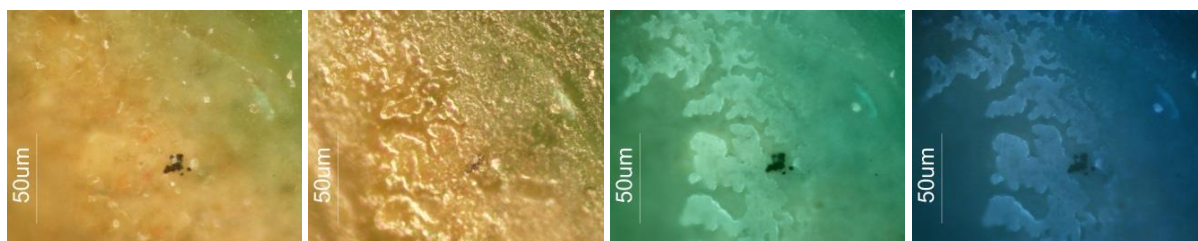
Figure II.8 – Detail of the underside of the paint fragment represented in Figure II.5. Left to right: normal light, bright field, Filter set 5 (BP 395-440, FT 460, LP 470) for fluorescence and UV light (x500).

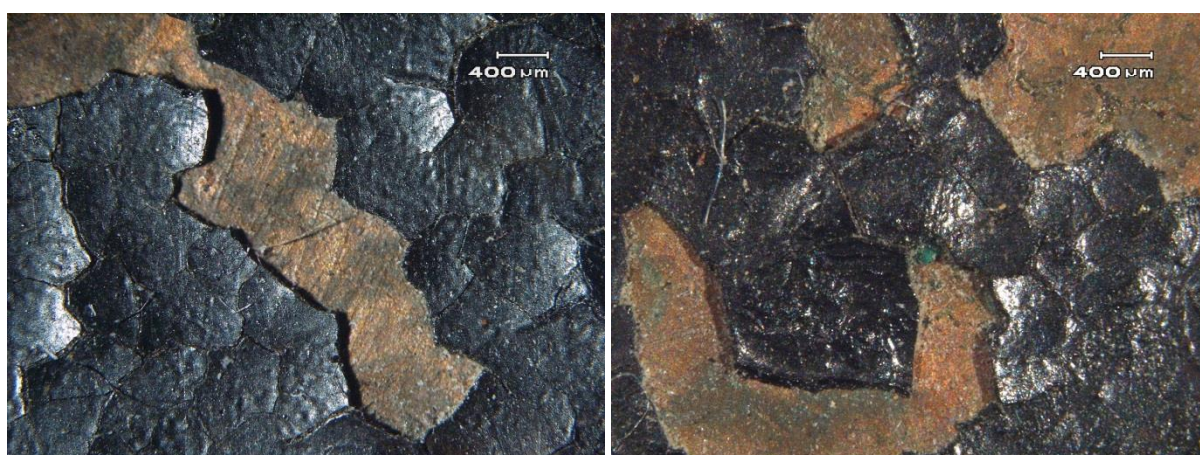
Figure II.9 – Two details of flaking paint (x40).

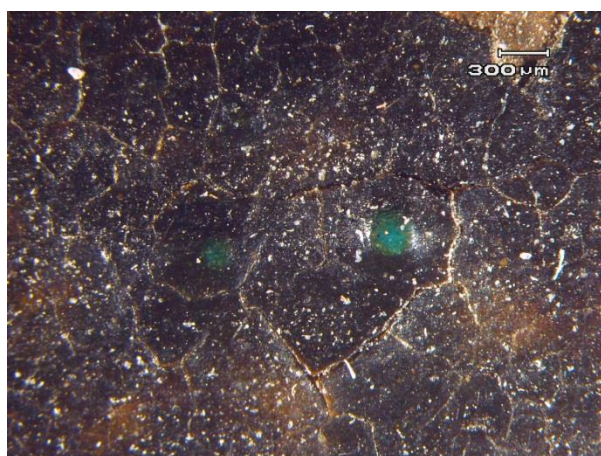
seems to be slightly pushed up, creating that visual effect. It is also important to mention that the green circles were also observed in other colour areas, but less frequently.

Figure II.10 – Green protrusions (x50).

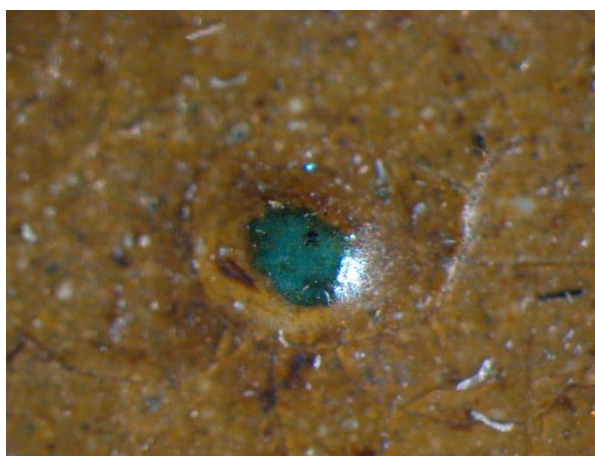
Figure II.11 – Green protrusion (x80).

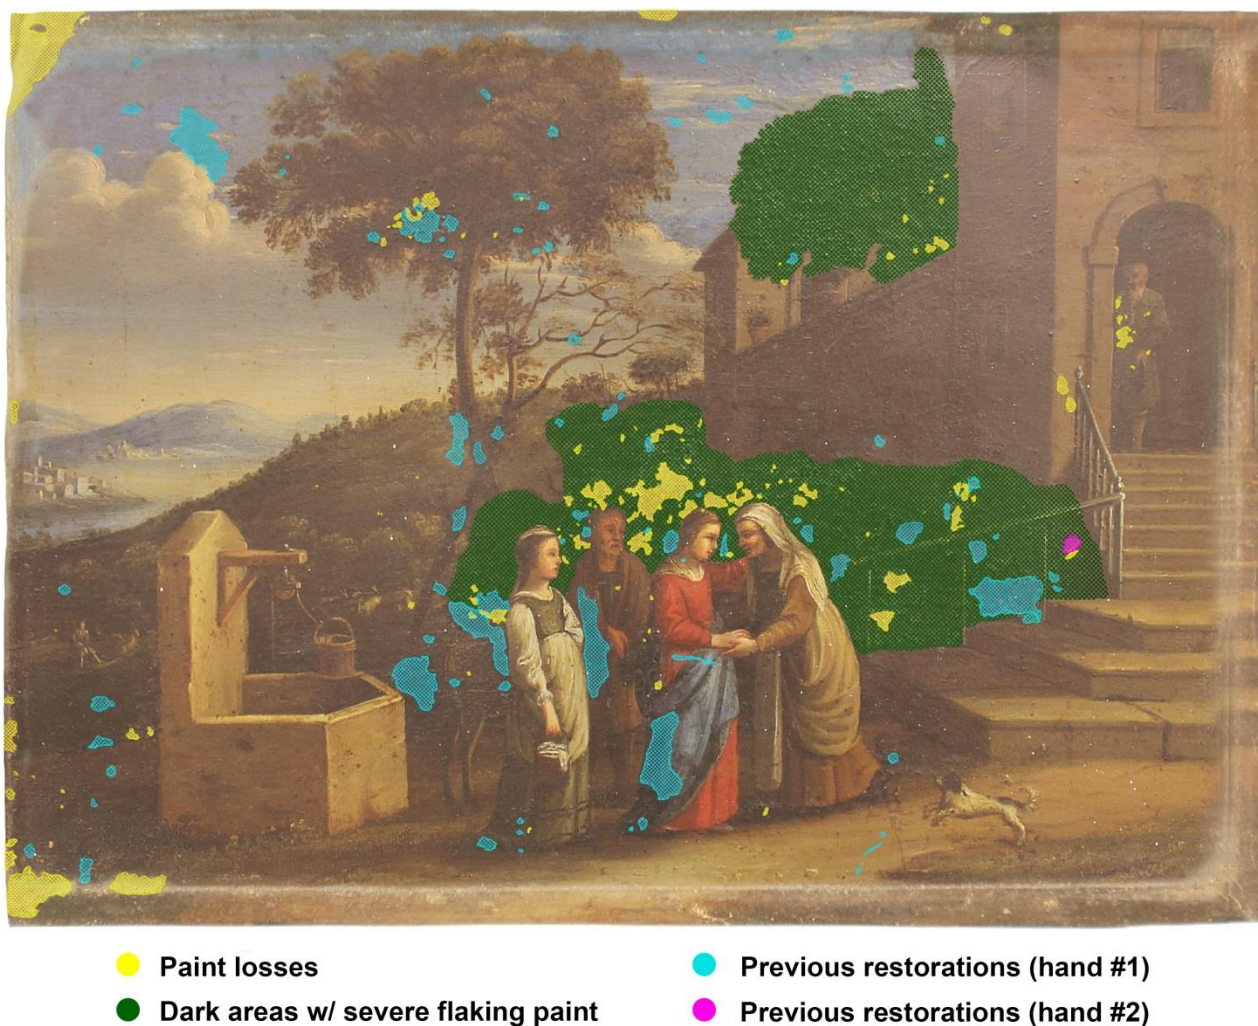
The two upper corners of the copper plate exhibit out-of-plane undulations: in the upper left corner, damage originated from the left side of the plate; and in the upper right corner, coming from the top diagonally. The deformations might have happened in the process of framing, although the current frame is quite loose-fitting and none of the edges of the copper plate, with the exception of the bottom one, were in contact with the wood when the painting first arrived in the department. The deformation of the left corner is more severe than the one on the right, and because of that it resulted in a paint-loss of considerable size (approx. 3.5cm x 2.5cm) (see Appendix III, Map of damages); no paint delamination occurred on the right corner.

Figure III.1 – Mapping of *Visitation* condition.
